Manhole Inspection Summary

Manhole # S21E1_024MH

Insp Date: **5/22/08 11:34 AM**

Location Address: **2653 ridgely-huron alley**

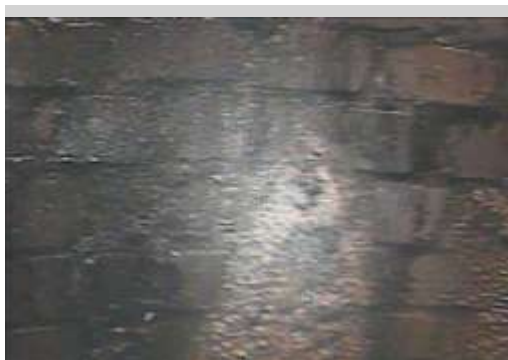
Defect 6

Infiltration: ☐ None ☐ Joint ☐ Cracks ☐ Mortar ☐ Roots ☒ Wall

infiltration @ barrel wall

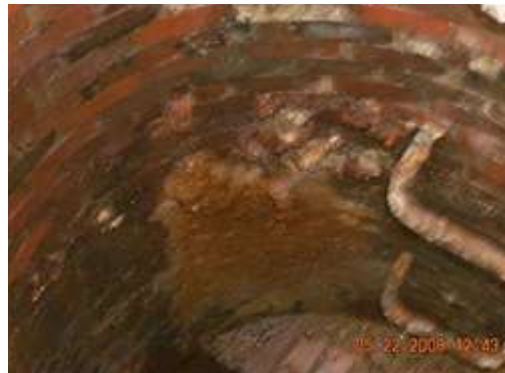
Defect 5

Condition: ☐ Sound ☐ Cracked ☐ Root Intrusion ☐ Loose Brick ☒ Deteriorated

encrustation/deterioration of barrel wall

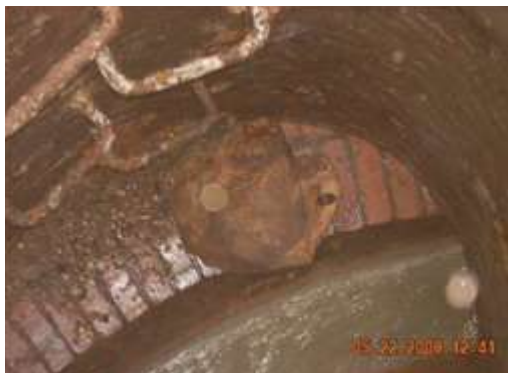
Defect 4

Condition: ☐ Sound ☐ Cracked ☐ Root Intrusion ☐ Deteriorated ☐ Leaks ☒ Debris

debris on bench

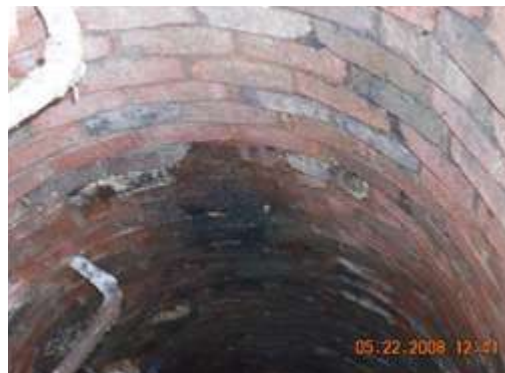
Defect 3

Infiltration: ☐ None ☐ Joint ☐ Cracks ☐ Mortar ☐ Roots ☒ Wall

infiltration @ corbel wall

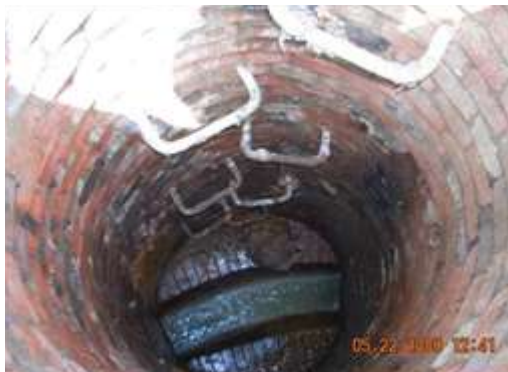
Defect 2

Steps Count: **7** Missing: **0** ☒ Corroded

corroded steps

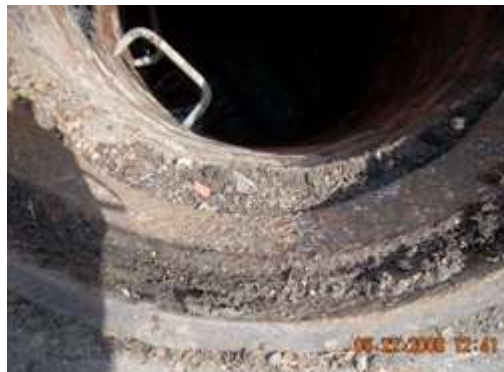
Defect 1

Frame Offset: **2** (in.) Condition: ☒ Sound ☐ Cracked ☐ Leaks

frame offset
